## PROPERTY CONDITION REPORT

### Shopping Center

1234 Main Street  
Anyplace, USA 00000

Month 03, 2015

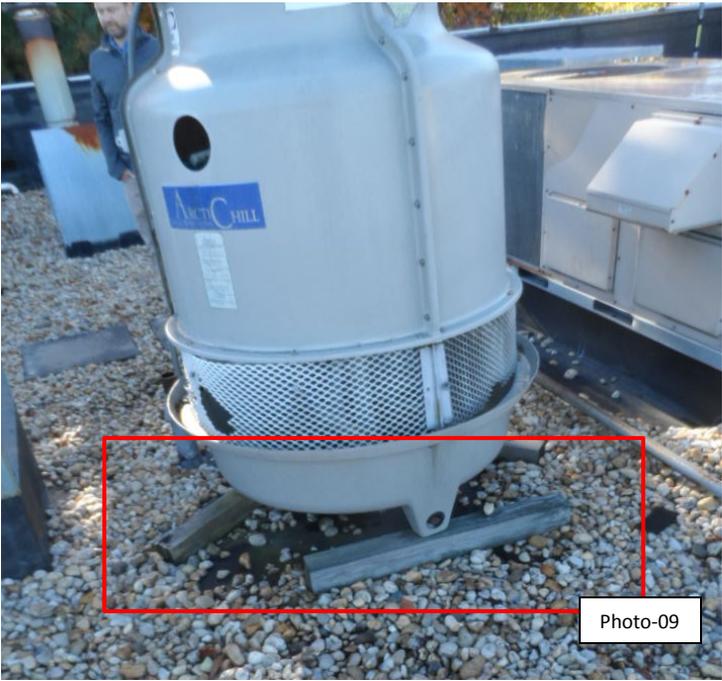
Photo-09

Presumably, tenants have had roof top equipment installed after [YEAR], which have been improperly mounted on wooden pallets, wooden dunnage/sleepers, or other material not compliant with typical manufacturer's installation details for equipment rails and curbs (**SEE Photos #05 - #11**). Further, tenants have penetrated the roof with various conduits leading to and from tenant-installed equipment, which have not been properly sealed via pitch-pockets, weathertight pipe boots, or uncured laminate tape as applicable (**SEE Photos #05, #10, & #12**).

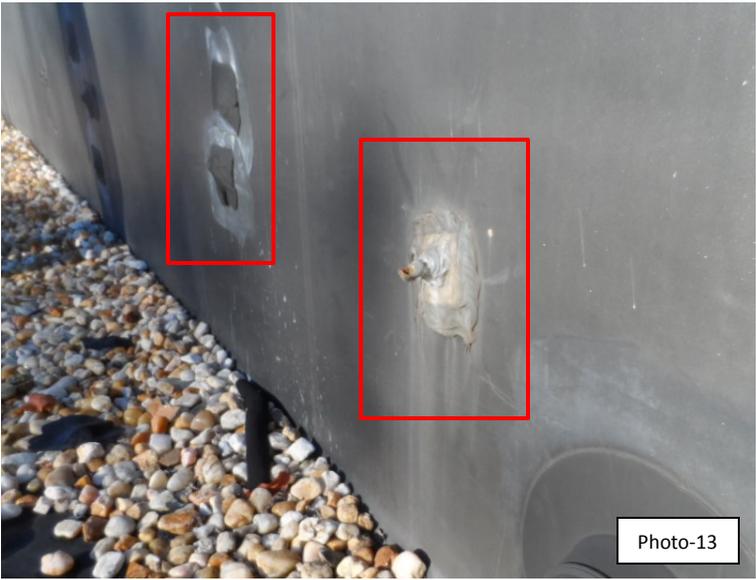
Photo-13

The roofing membrane on the rear of face of the front parapet wall has been compromised by tenant building signage anchored through the wall as depicted in **Photos-#13 and #14**.

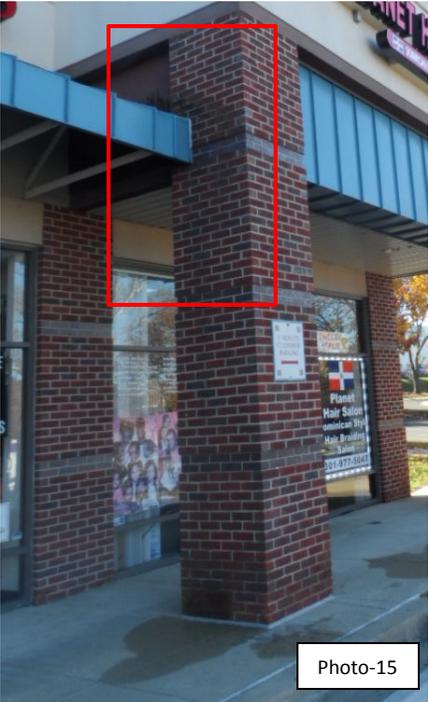
Photo-15

Side-wall flashing is missing at the intersection of the standing seam roof and the brick veneer as evidenced by the discoloration and saturated masonry shown in **Photos-#15 and #16**. Refer to Section 1.1 of Appendix-B for the proper flashing detail.

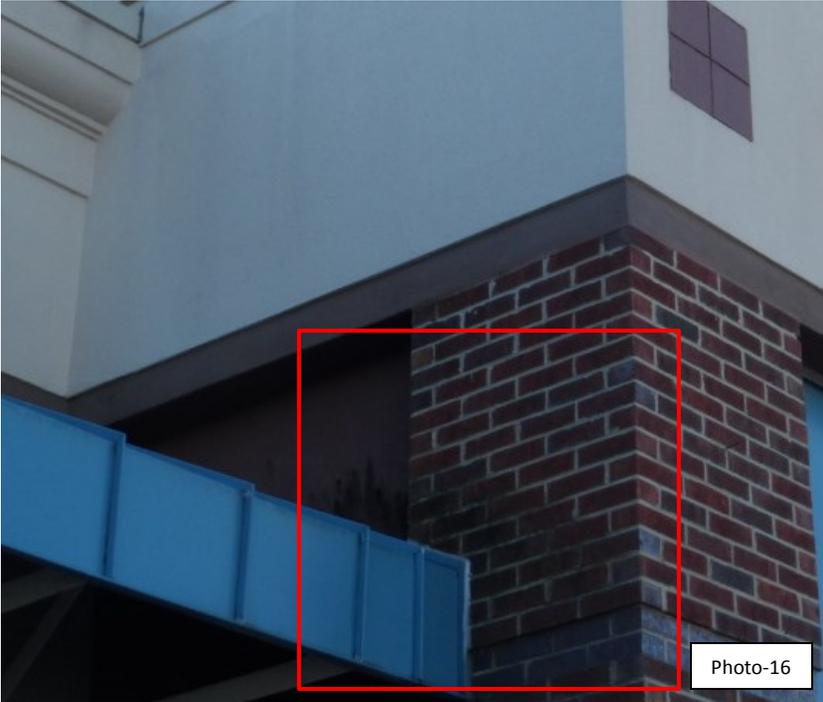
Photo-16

Additionally, no gutter for the tower roof above allows rainwater which collects on that roof surface to spill onto the roof below as well as cascade down the wall finishes. Neither weeps nor was evidence of base-course flashing observed in the brick veneer that wraps the column shown in **Photo-#16**. Moisture is likely penetrating the veneer as clearly indicated by the discoloration of the saturated masonry at the intersection with roof, and is likely accumulating within the column structure with no means of outflow except by vapor emission.

This column and others with the same condition at the standing seam roof should be regularly and closely monitored for signs of internal moisture damage until sidewall flashing is properly installed.

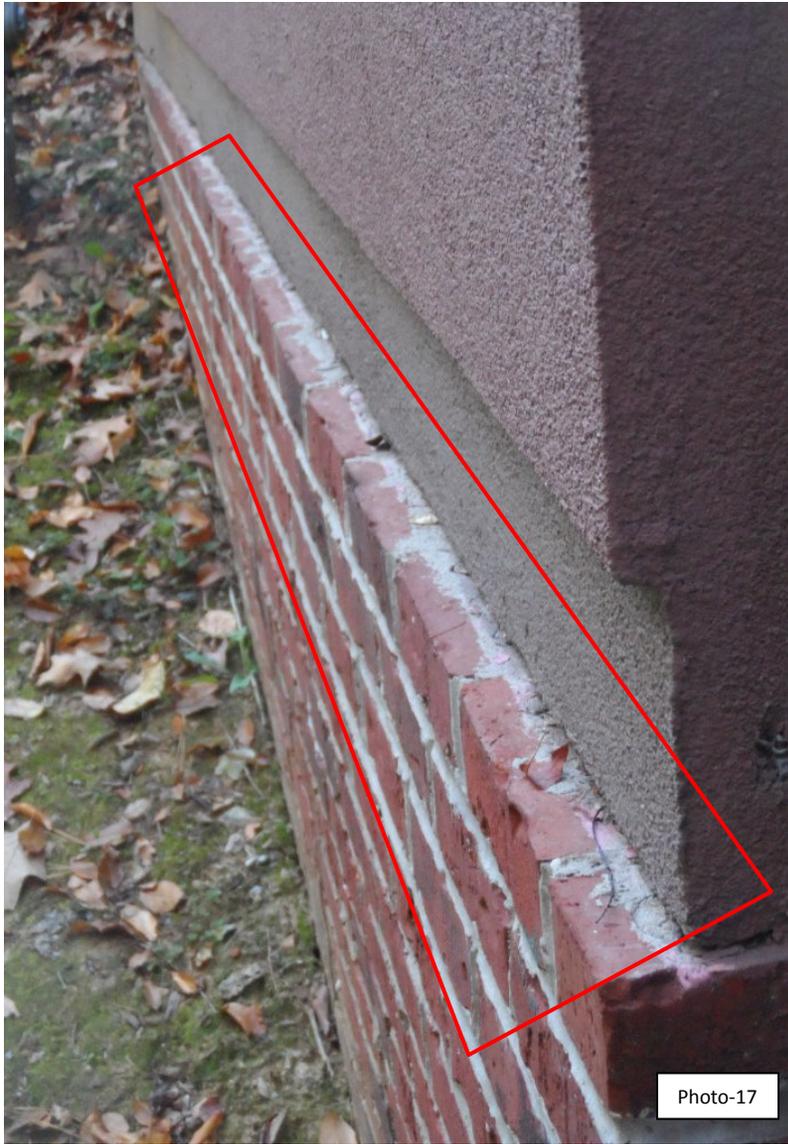
Photo-17

**Photos-#17 - #19** depict areas at the rear and side of the building where EIFS terminates horizontally at brick veneer. Per Dryvit detail OS 0.0.24 continuous flashing is required at the intersection between the EIFS and masonry veneer, none of which was observed to be installed per the detail. If any flashing was installed but not visible beyond the caulked joint, it has been improperly formed such that the length of the hemmed horizontal leg below the EIFS is insufficient to extend beyond the caulking. Properly installed flashing is intended to channel away any condensation or water that accumulates behind the EIFS lamina and drains down to the base flashing, then out and away from the top of masonry. The as-built condition does not match this design.

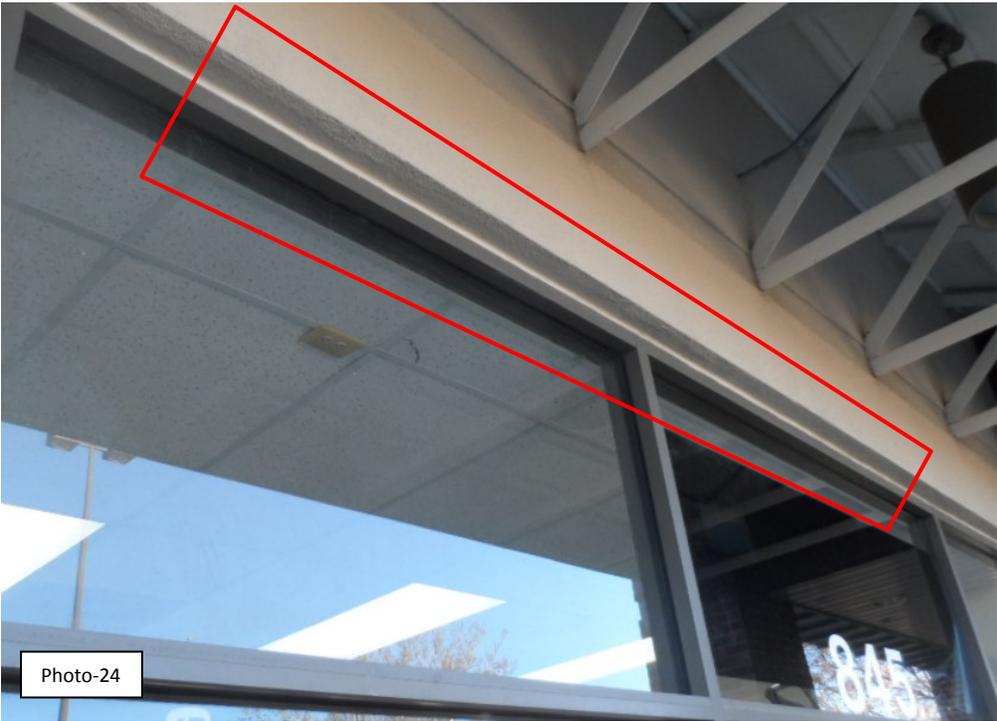
Photo-24

**Photos-#24 - #26** depict the horizontal terminations of EIFS at the storefronts. The EIFS lamina is blistering and spalling as shown in the photographs and is very likely due to improper terminations at the heads. No evidence of flashing was observed at the storefront heads as is required by Dryvit detail OS 0.0.10.

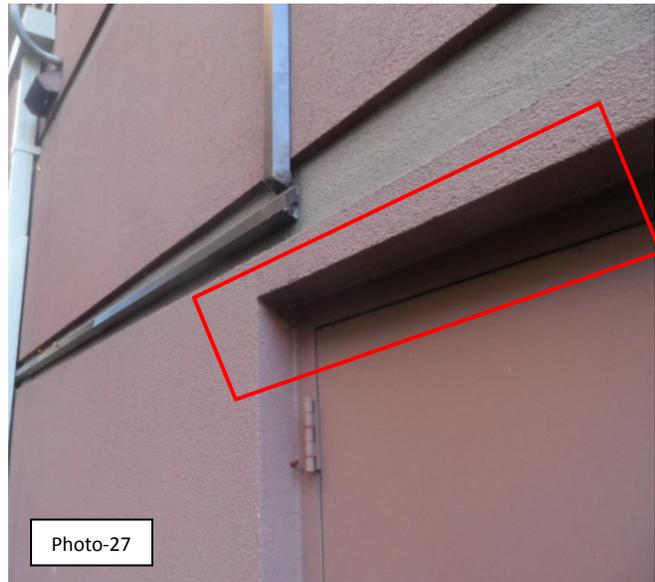
Photo-27

Head flashing is also required at the horizontal termination of EIFS above the door shown in **Photo-#27**. No flashing was observed. Further, the EIFS soffit detail above the door is not properly installed in accordance with Dryvit soffit details.

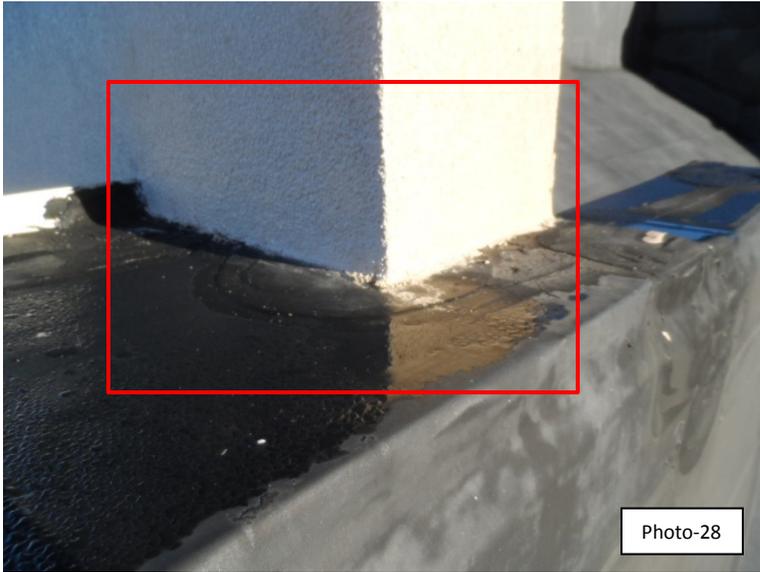
Photo-28

**Photos-#28 - #31** as well as the lower right boxed area of **Photo-#32** depict improper terminations of EIFS at the roof parapets. Refer to Dryvit details OS 0.0.16 for the correct installation and flashings.

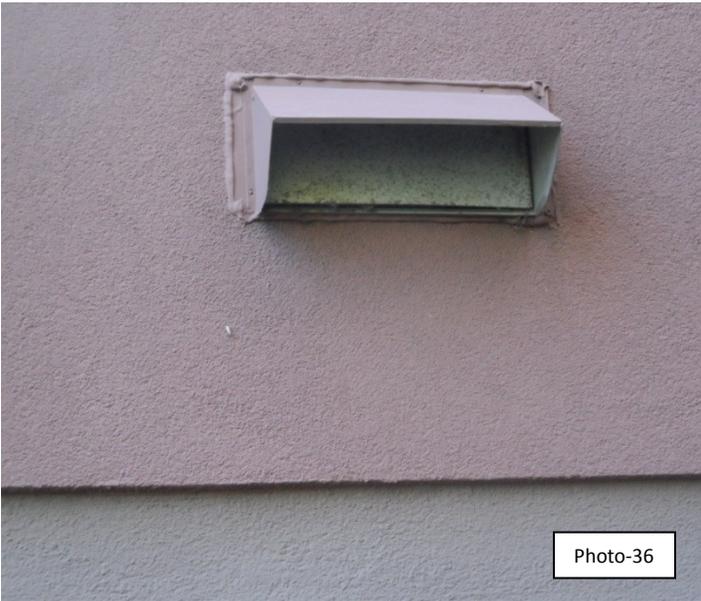
Photo-36

**Photos-#34 - #39** depict various penetrations through the EIFS of which rectangular openings should be properly flashed and round penetrations properly caulked in accordance with applicable Dryvit details. None of the rectangular openings shown in these photographs were observed to be flashed properly; and, the stand-off bolts anchoring the gas service line in Photo-#39 did not appear to be sealed in accordance with manufacturer's installation requirements and details.

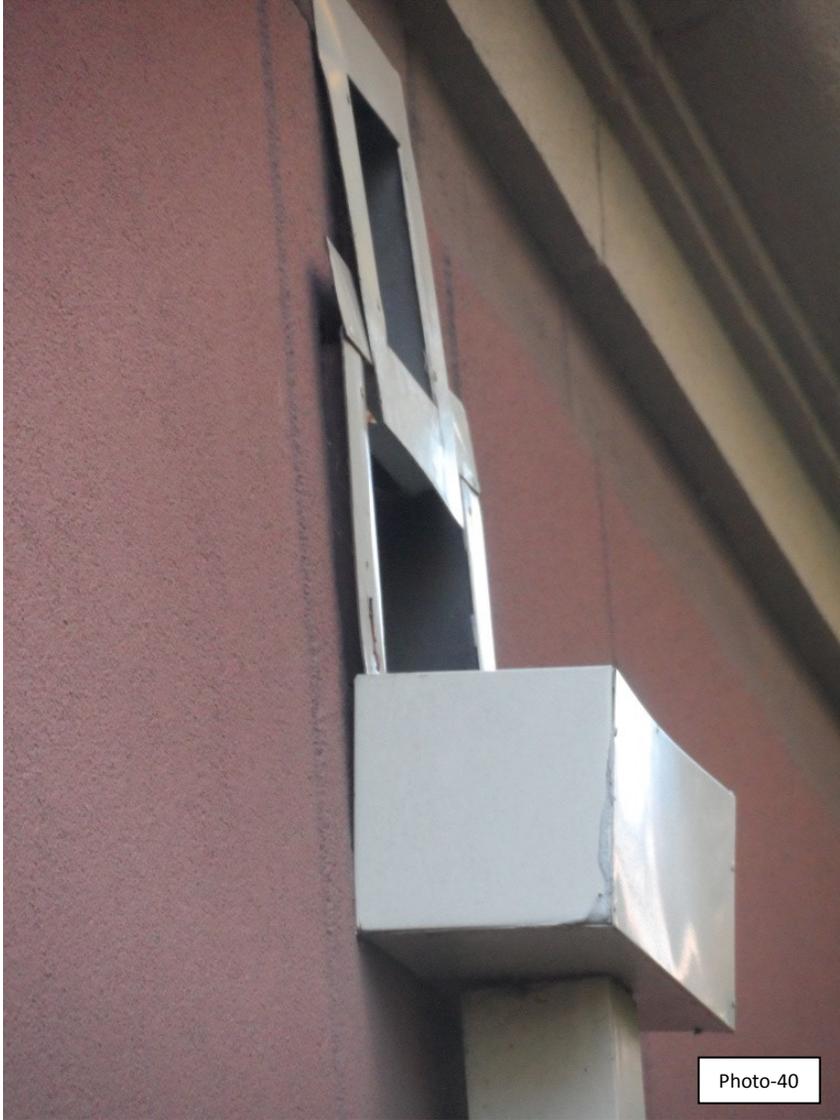
Photo-40

The conductor head (also referred to as scupper head) depicted in **Photo-#40** has been improperly fastened to the EIFS finish. This same condition was observed at all of the conductor heads.

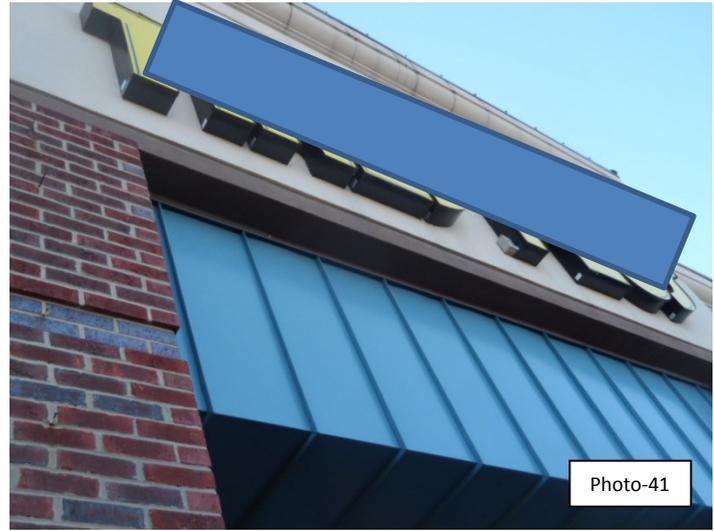
Photo-41

The tenant building signage for all tenants has been improperly anchored to the EIFS (**SEE Photos-#41 - #45**). Refer to Dryvit detail OS 0.0.28 for the correct anchoring detail. A minimum ½" clearance is required by the manufacturer between the signage and the face of the EIFS. This is achieved by appropriately sleeving the anchor bolts and installing bearing washers or nuts against the backside of the signage components.

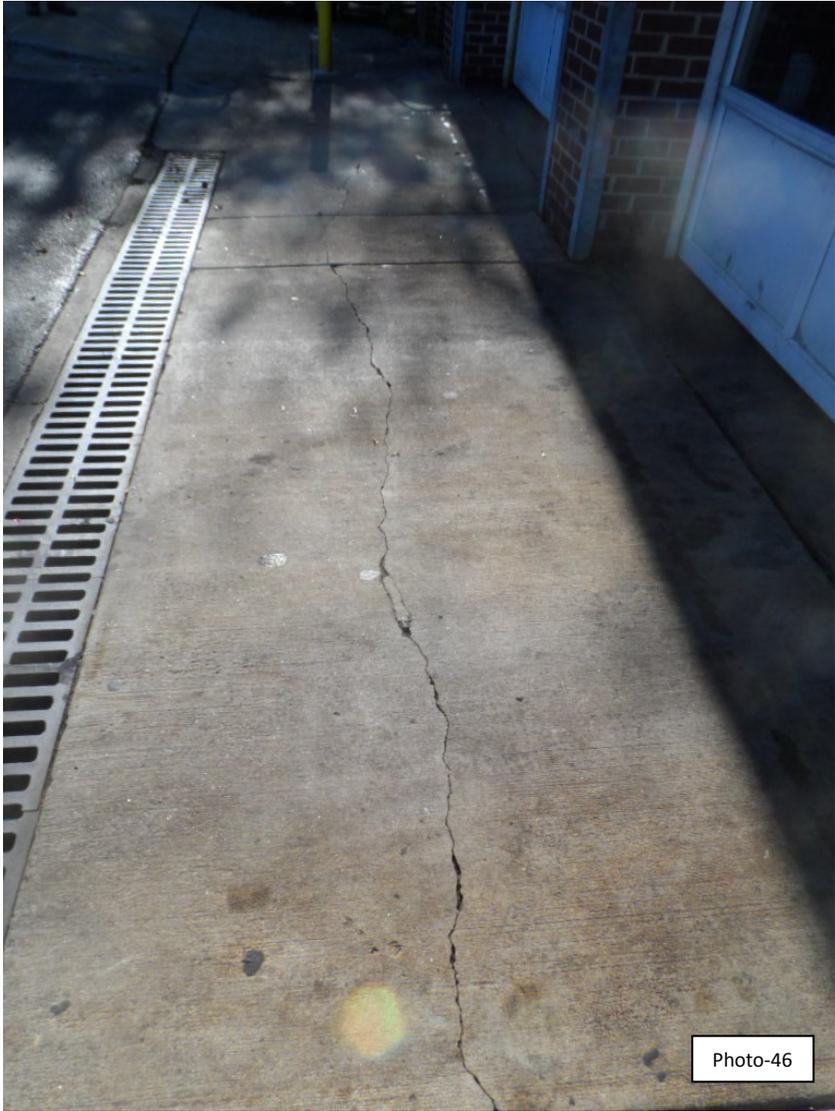
Photo-46

Fractures and cracking in various concrete pavements around the building are depicted in **Photos-#46 - #50**. In each case the concrete has failed due to improper expansion joints or to a lack of expansion joints. Most commentaries on concrete pavement cracking attribute the loading forces to freeze-thaw cycles; however, concrete thermally expands and contracts similar to asphalt pavements without necessarily freezing temperatures. When the forces generated by thermal expansion exceed the compressive strength of the concrete, the result is uneven warping and buckling of the pavement ultimately manifested in visible cracks.

The same failure likely occurred with the concrete apron in Photo-#46 and #47 to cause the cracking if not due to heavy axle-weight overloading the pavement.

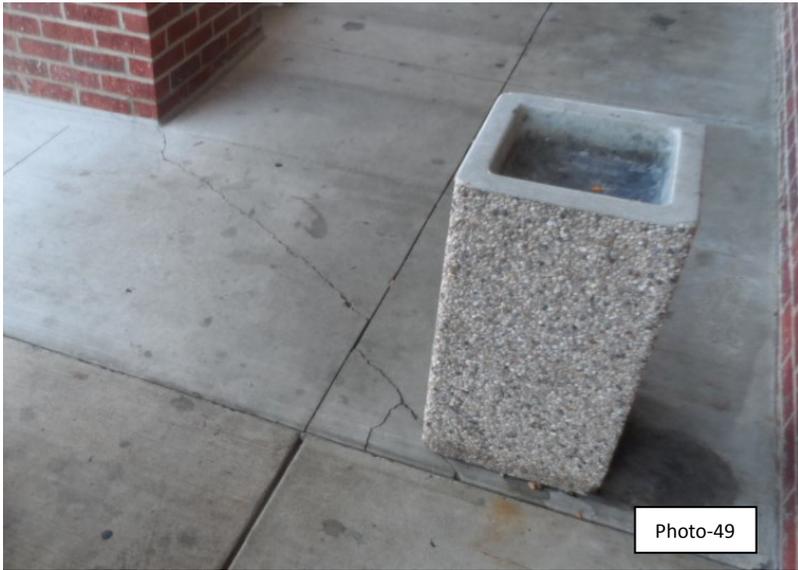
Photo-49

Inadequate tolerances for expansion joints as well as lack of maintenance to keep joints free of incompressible debris lead to most failures in concrete sidewalk pavements. Photo-#49 is a good example of the pavement without expansion joints expanding between two resistive structures, which resulted in the fracture depicted in the photograph. Saw-cut control joints are inadequate for the compressive stresses that lead to cracking because such saw-cut joints are intended to minimize shrinkage cracks.

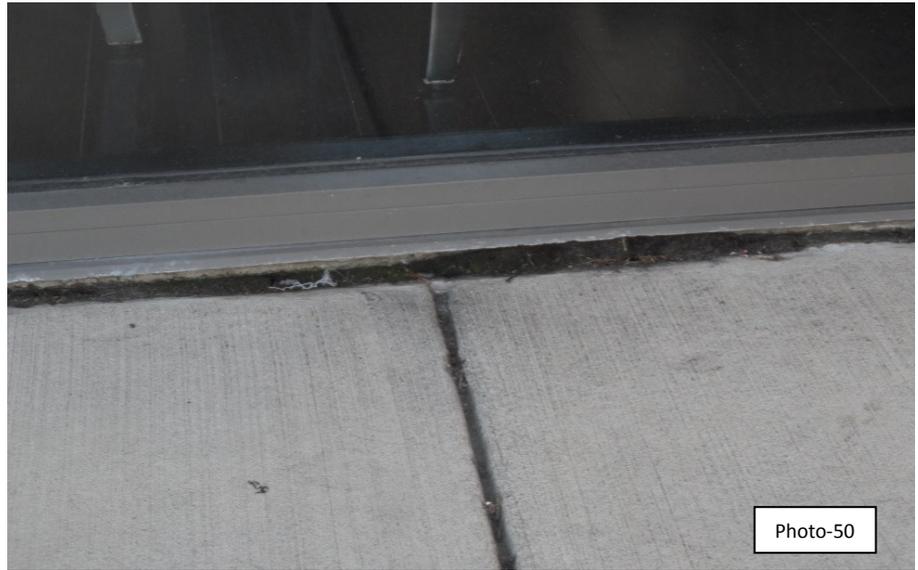
Photo-50

**Photos-#50 and #52** depict sections of the front sidewalk at storefronts. Either the concrete pavement has unevenly settled or was placed without adhering to the specified or acceptable level tolerance.

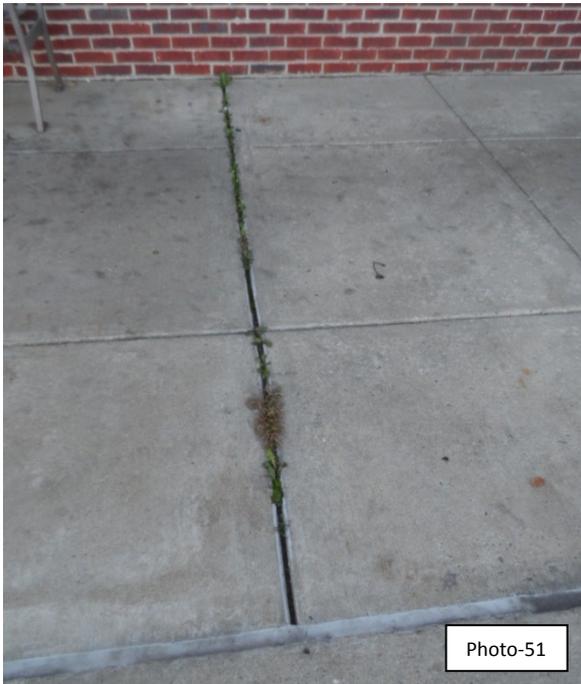
Photo-51

**Photo-#51** depicts plant life growing in an expansion joint which reveals not only a lack of routine maintenance to keep the joint clean, but also an improper sealant applied in the joint. Debris accumulating in an expansion joint commonly reduces the free movement of the pavement as thermal expansion occurs leading to uneven compressive forces on the concrete that buckle it causing fatigue and eventual failure.

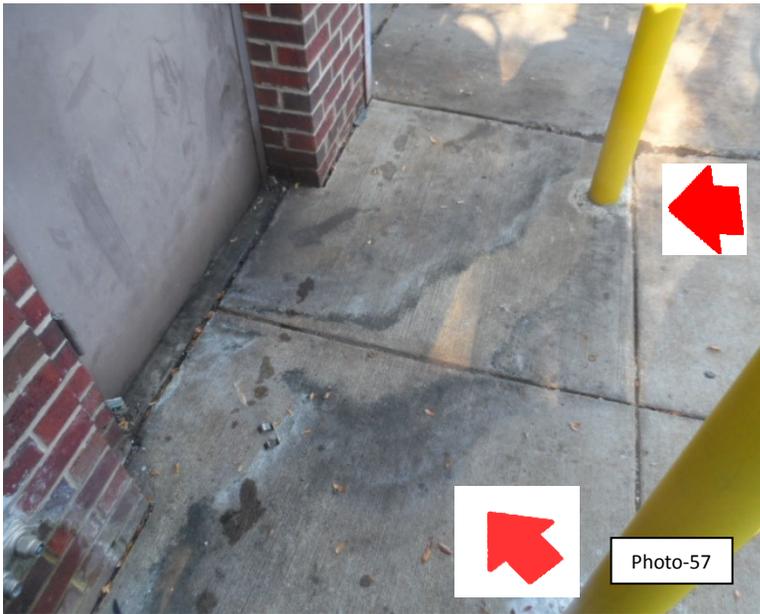
Photo-57

**Photo-#57** depicts the negatively sloped concrete pavement located on the southeasterly corner. Staining reveals ponding water and poor drainage. The concrete pavement should be replaced to achieve positive drainage and the adjacent asphalt pavement milled and resurfaced accordingly.

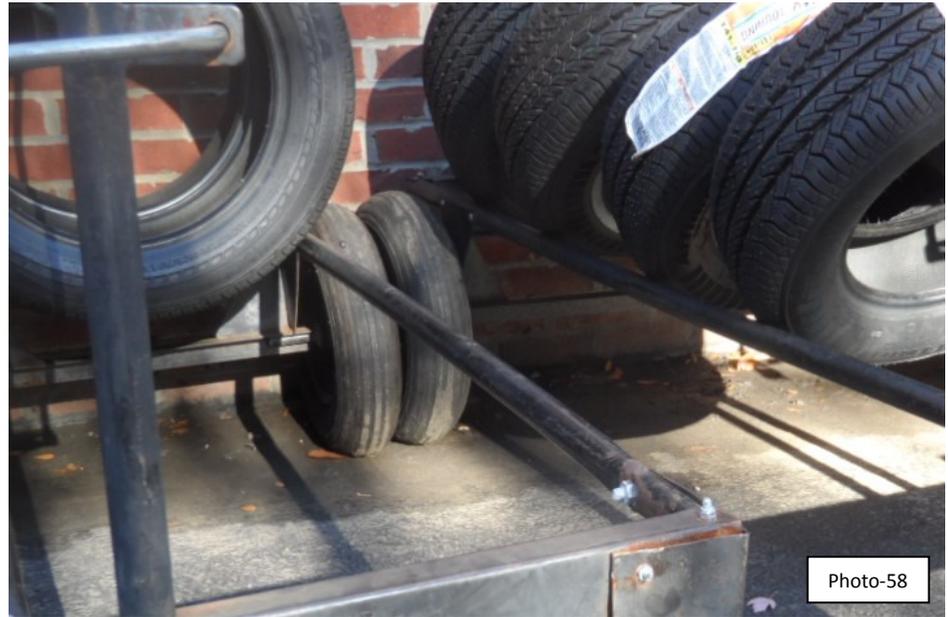
Photo-58

The pavement is negatively sloped at the rear of the building where tire storage racks are located. **Photos-#58 and #59** show the accumulated silt in the wet areas against the rear building wall evidencing improper slope and poor drainage, which is compounded by the storm water surface-discharged by downspouts. The asphalt pavement should be milled in this area and resurfaced to achieve positive drainage.

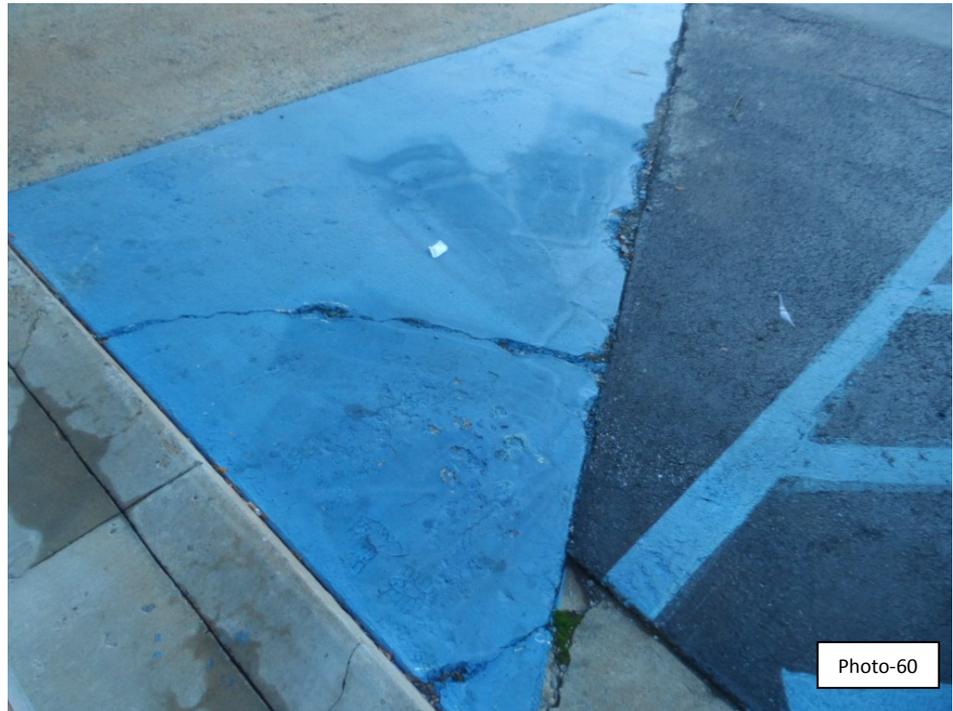
Photo-60

**Photo-#60** shows the stress cracking in the east side of the accessible ramp. The ramp material appears to be concrete, painted blue on both flanged sides and at the base of the ramp. Seemingly, the concrete ramp was constructed after original placement of the asphalt pavement as evidenced by the saw-cuts in the asphalt along the perimeter of the ramp.

The edges of the concrete at the intersections with the asphalt pavement are spalled and deteriorated allowing water infiltration which exacerbates the material decay.

Generally, accessible sidewalk ramps are constructed within the concrete sidewalk. In this case, the existing conditions of the as-built sidewalk would apparently not allow for the necessary length of run required for modifying it to achieve the ramp slope. Instead, extending a ramp from the curb out into the parking area was the implemented retrofit solution; however, the construction of the ramp and quality of concrete mix led to the current condition.

Replacing the ramp using a better design such as either a depressed concrete curb around the ramp perimeter with a concrete ramp or a HMA ramp to reconstruct it will provide more durability.

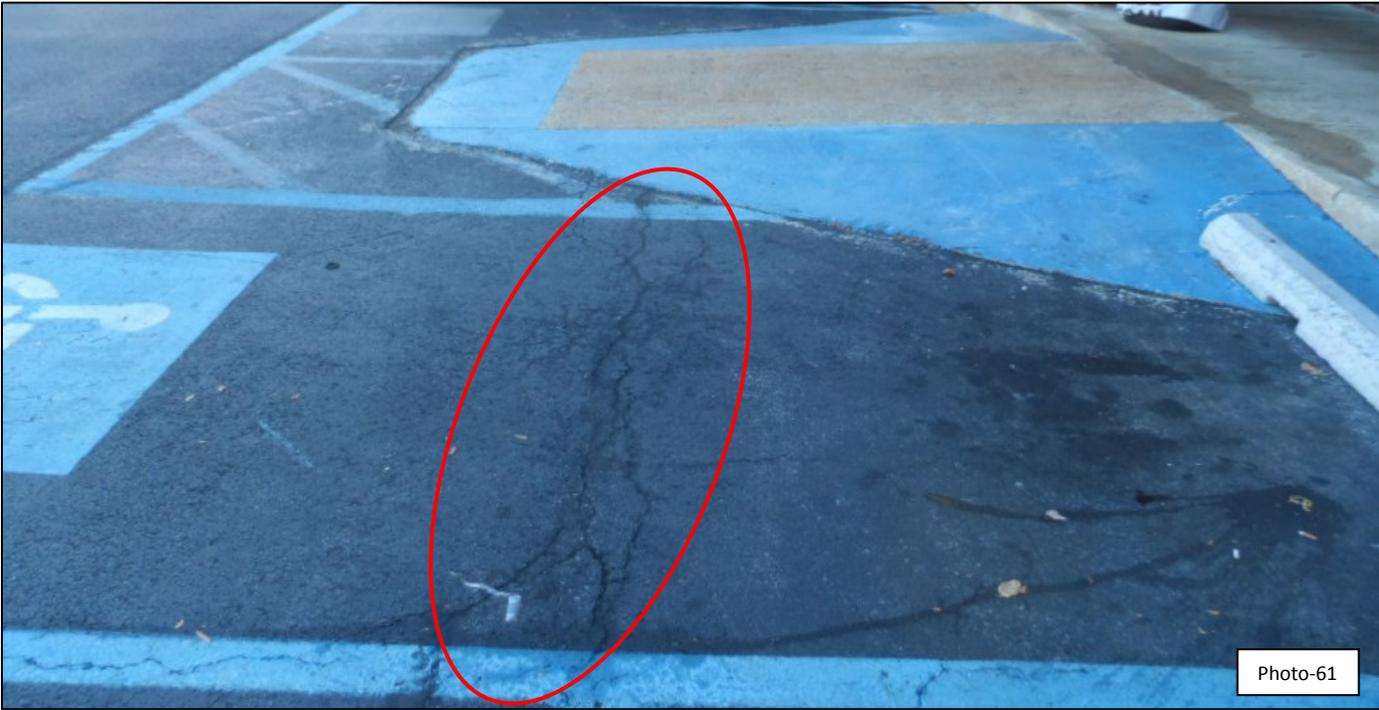
Photo-61

**Photo-#61** shows cracking in the asphalt surface in a direction across the parking space parallel and between the two axles of an automobile, which indicates possibly a weak subgrade in this area; improper placement; and/or due to heavy-axle loading (i.e., concrete mixer truck positioned across the parking space during the concrete ramp pour). Test-pitting this area is suggested to identify the cause before milling and resurfacing.

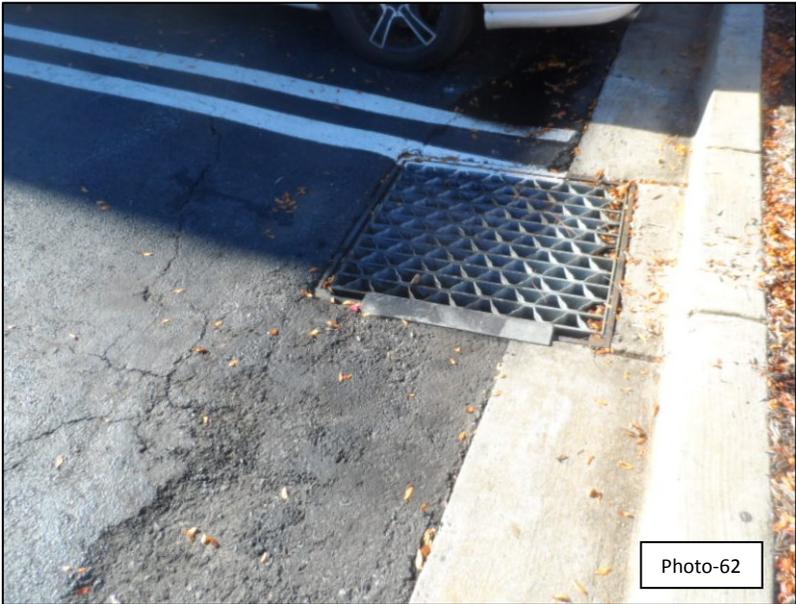
Photo-62

**Photos-#62 and #63** depict settlement/fatigue cracking and depression very likely due to inadequate fill and weak or uneven subgrade compaction around the inlet structures. Milling and resurfacing may not prevent future pavement distress if the subgrade or the fill around these structures cannot uniformly support the loading. Presumably, settlement over time has naturally resulted in some increased density of material, but unlikely consistent. For maximizing the longevity of the pavement life investigating the subgrade in these areas is recommended.
